## APPENDIX B: HULL SURVEY

### Marine Survey MV LIGHTNING

VESSEL	: M/V LIGHTNING
OFFICIAL NO.	: 1048476
DOC. OWNER	: Massachusetts Bay Transportation Authority
LENGTH	: 75.8' (registered)
BREADTH	: 27.6'
HULL DEPTH	: 8.5'
GROSS TONS	: 70 (regulatory)
GROSS TONS	: 141 (ITC)
NET TONS	: 47 (regulatory)
NET TONS	: 54 (ITC)
PROPULSION	: Twin diesel water jet
BUILT	: 1996 / Gladding-Hearn Shipbuilding, Somerset, MA / Hull # P-308

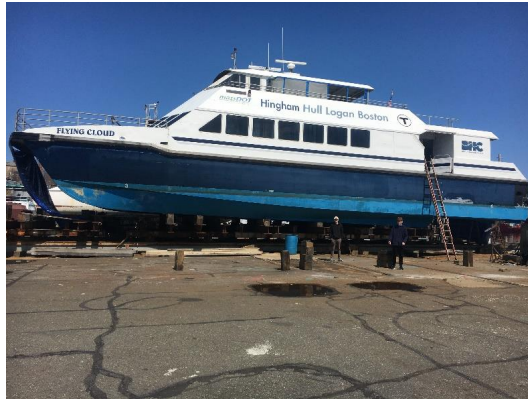
M/V Flying Cloud

is indicated to have occurred by replacing the core and inner laminate and leaving the outer skin intact while working from the inside of the vessel. The second repair is indicated to have occurred by replacing the outer skin and core and leaving the inside laminate intact. The foam core used in the original construction in the area was reported as H80 and it was replaced with a higher density foam A1200.

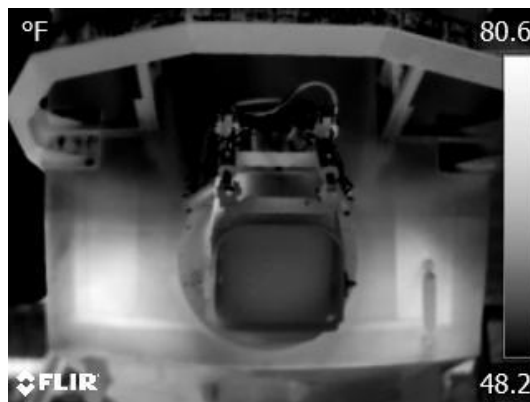
**IMAGE 52. Port hull stern**

The jet is seen mounted in monolithic laminate in dark color. A zinc anode is seen in the right of the image. The jet bucket guard is seen in the top of the image. No findings are noted

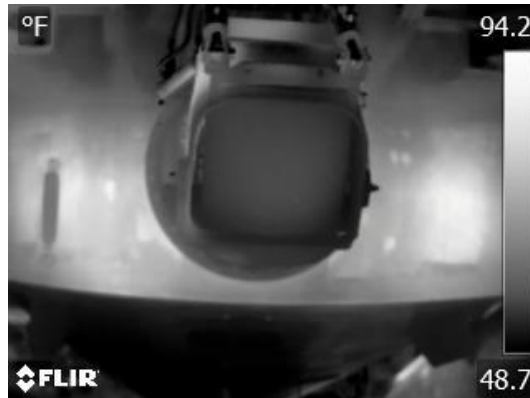
**IMAGE 53. Starboard hull stern**

The jet is seen mounted in monolithic laminate in dark color. Small anomalies characteristic of voids in the laminate are seen in light color.
